## Sunnyside Cogeneration Associates

RE: Annual 2001 Inspection Report

Please find enclosed a copy of the Annual 2001 Inspection Report for Sunnyside Cogeneration Associates' impoundments, refuse pile and excess spoil area. The inspection was performed by a professional engineer from Psomas and Associates Engineering.

**IMPOUNDMENT INSPECTION AND CERTIFIED REPORT**

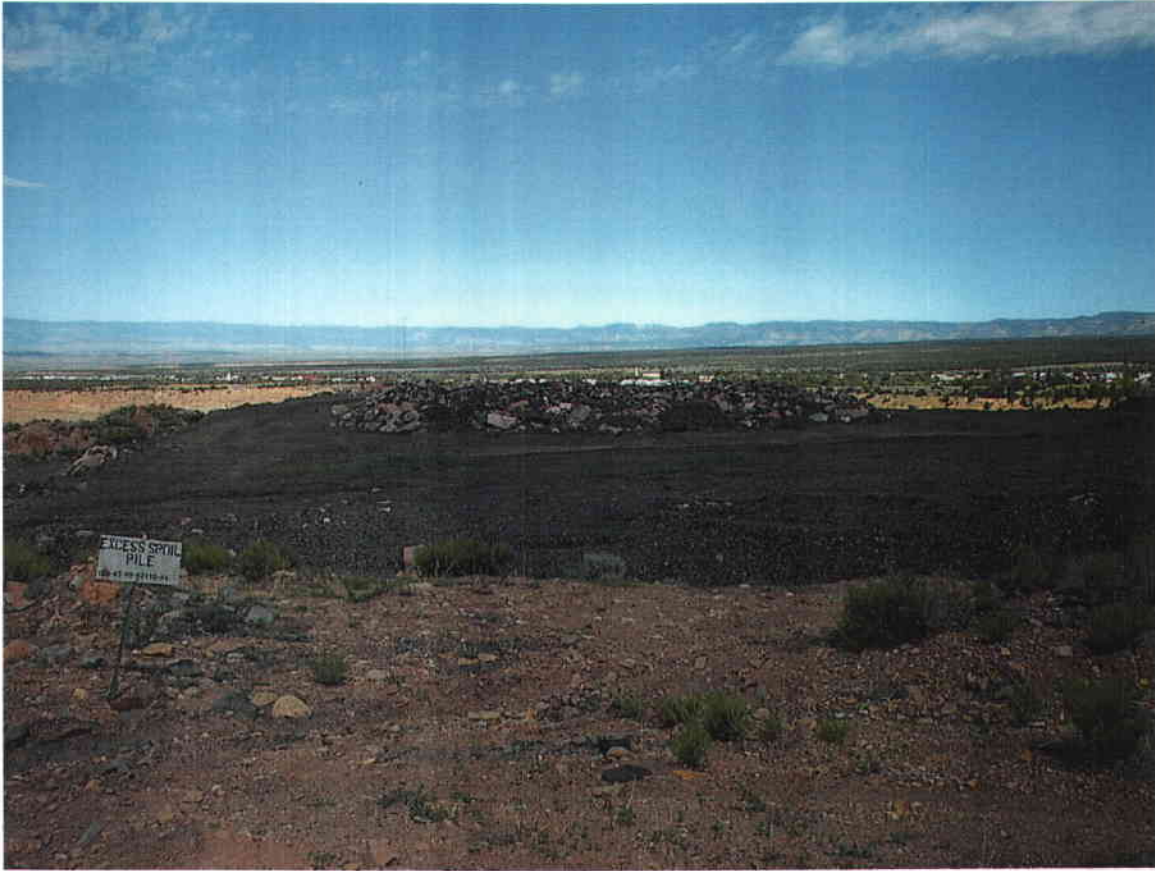
Excess Spoil Disposal Area # 1

No evidence exists of fires in the pile.

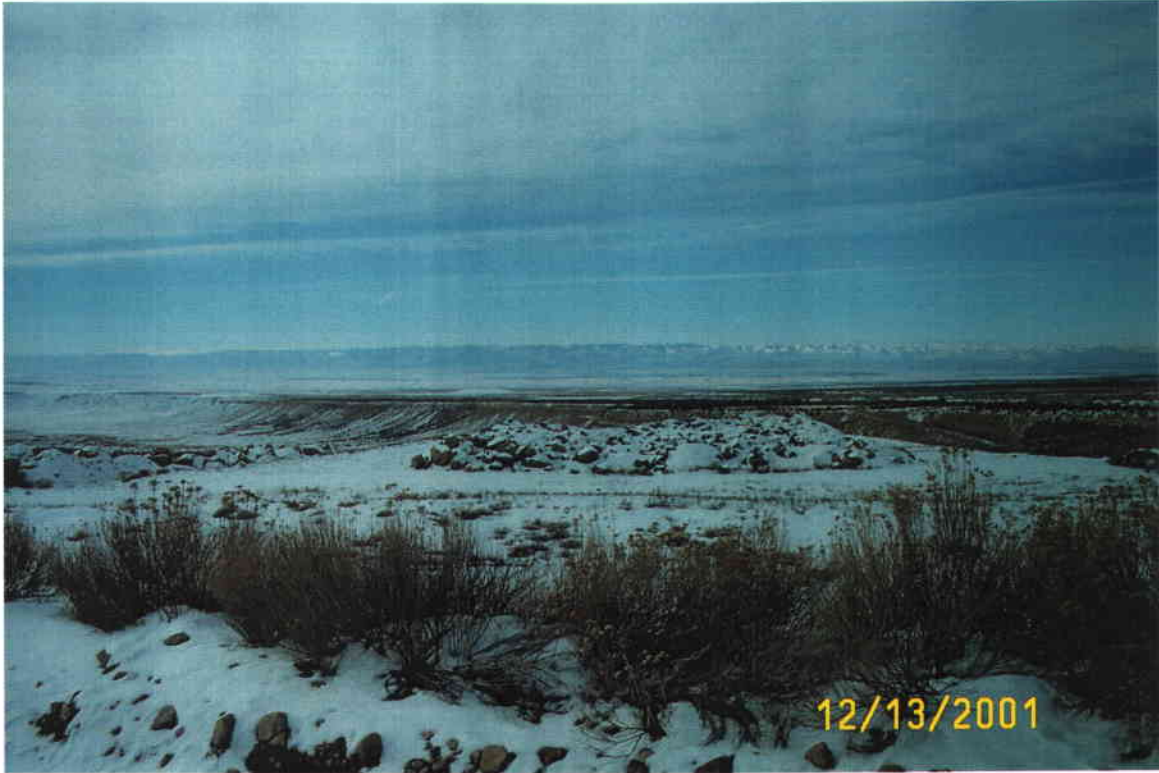
Excess Spoil Disposal Area #1

looking West/Northwest

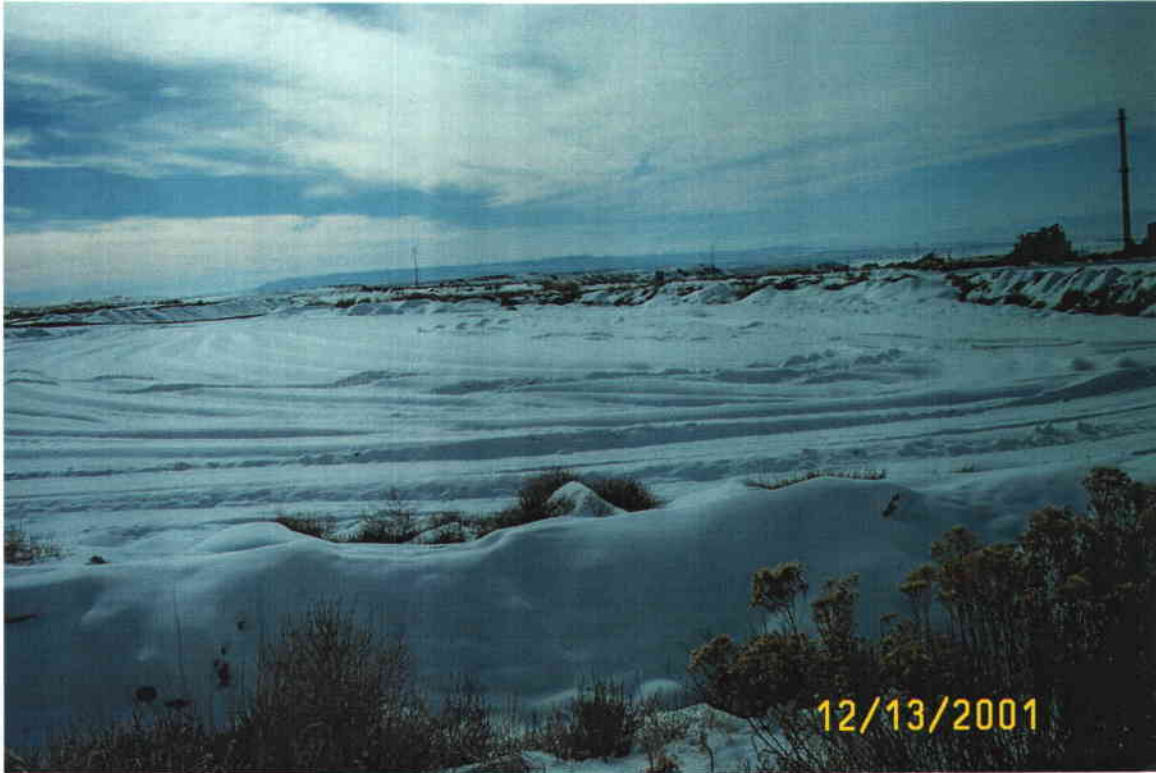
Excess Spoil Disposal Area #2      North portion looking south

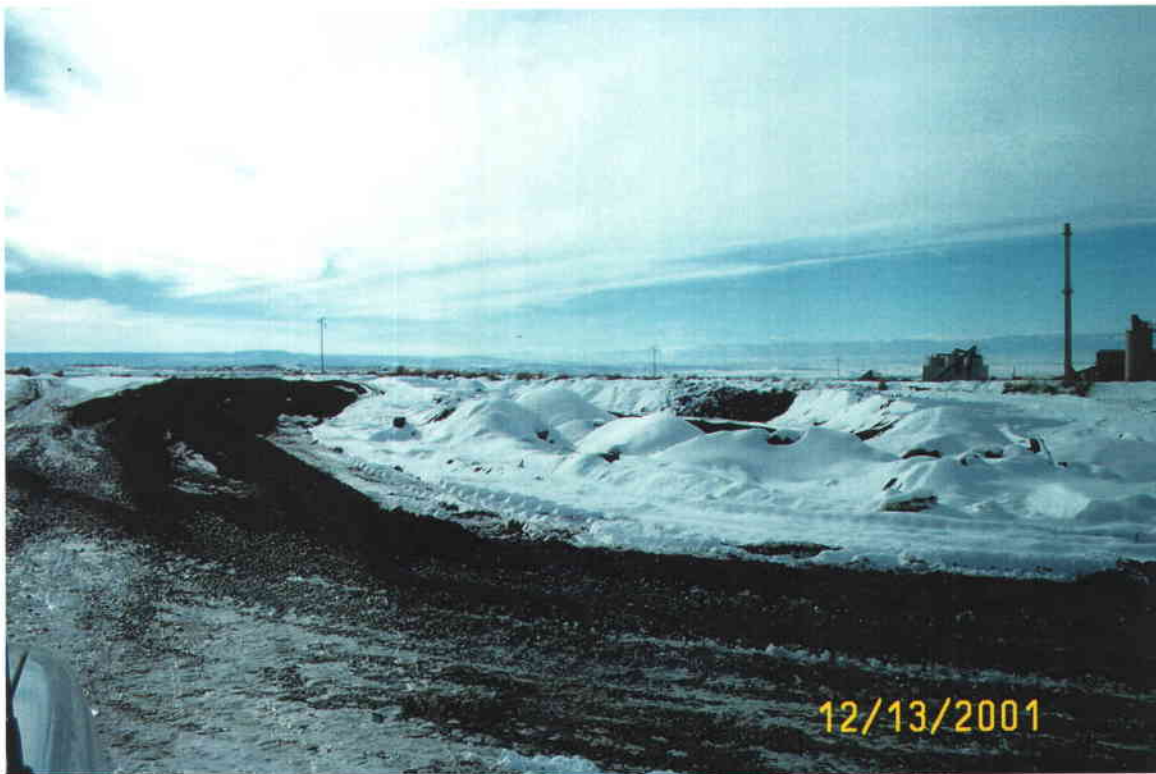
Excess Spoil Disposal Area #2      South portion looking south
